**Draft Capital Plan
Building Condition Assessment
Richmond Arena
3122 Whiteside Road, Louisdale
Richmond County, Nova Scotia**

**January 2019
Project Number 1801099**

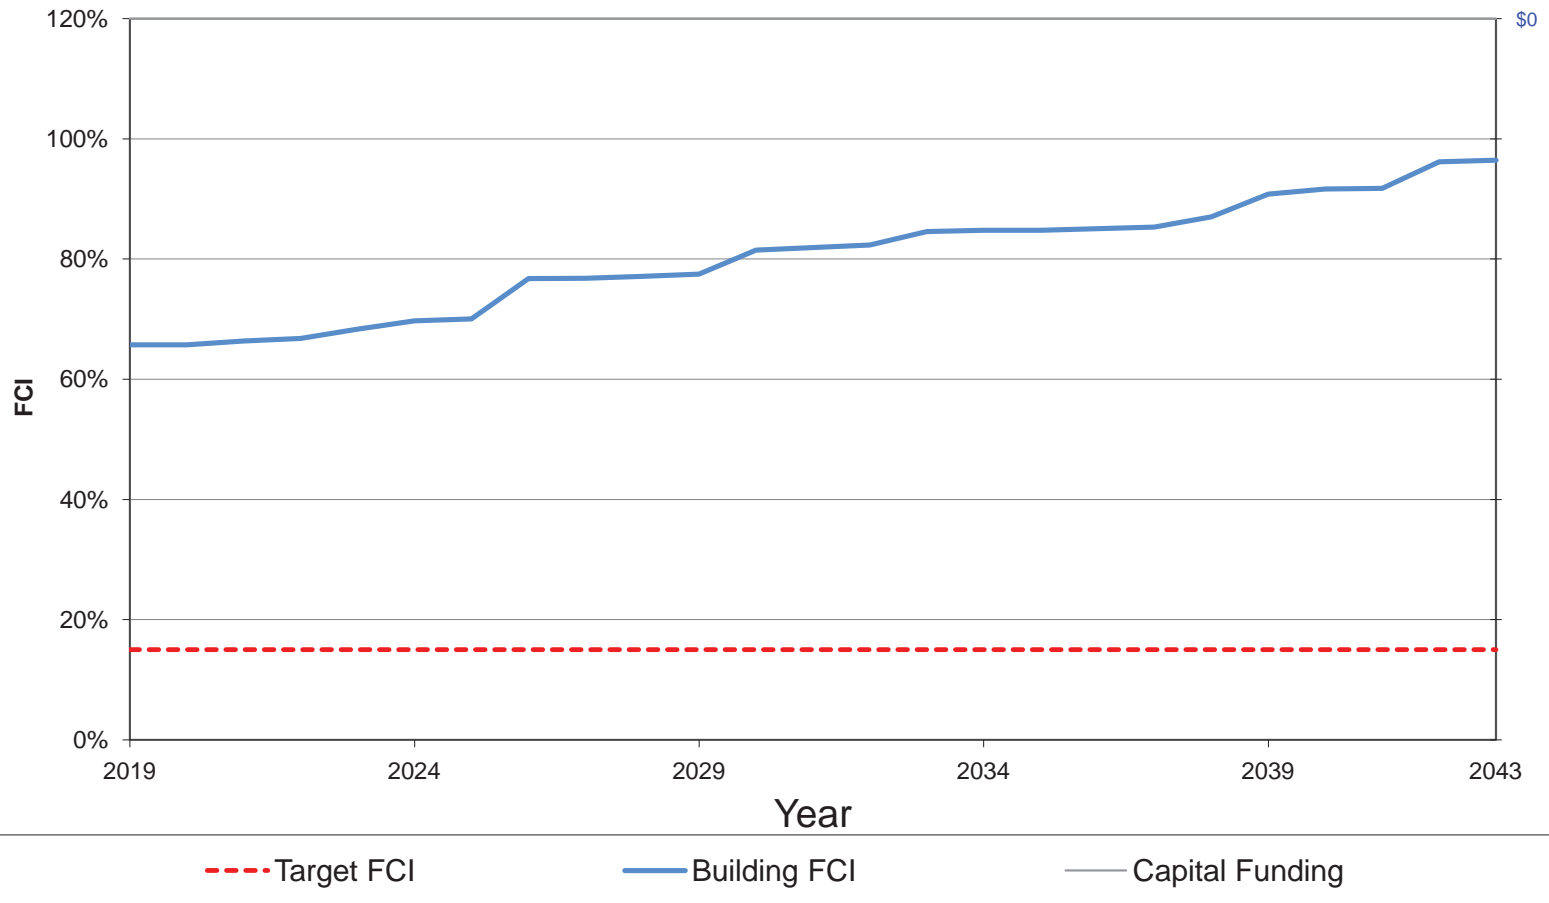
Recapitalization Costs by Year for Richmond County Arena

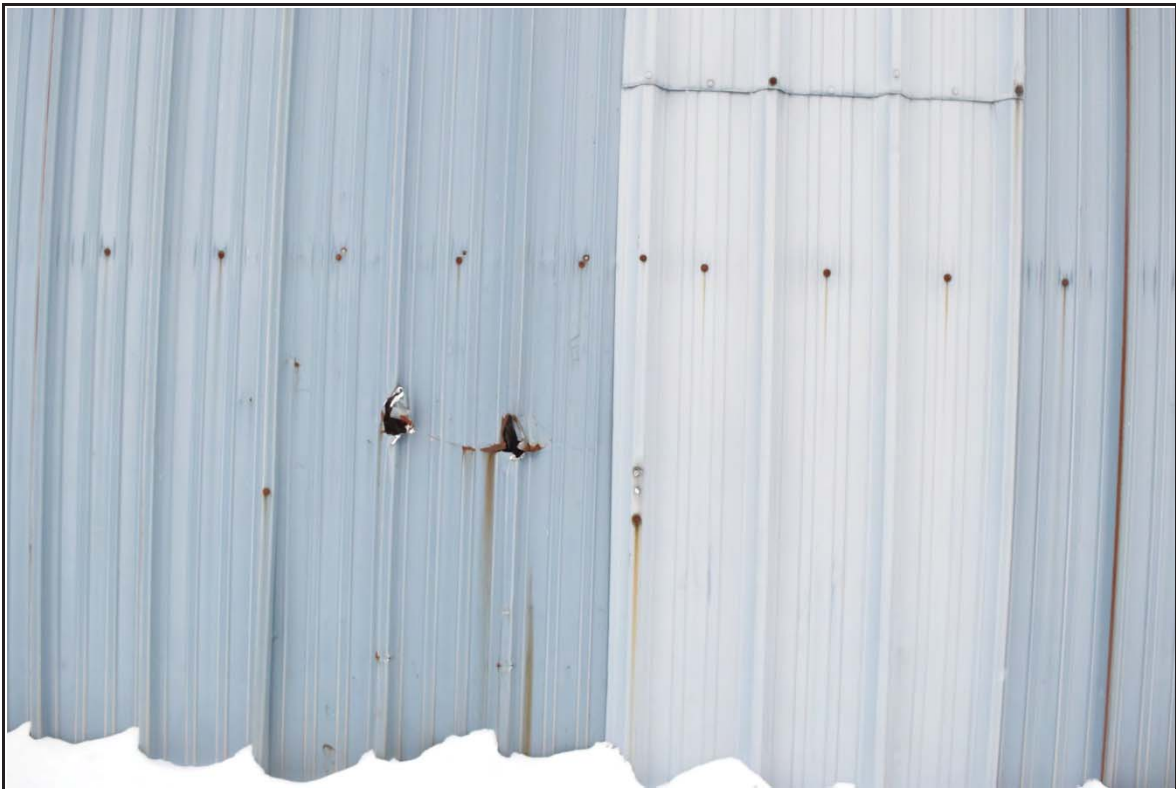
Photo 8: Damage to Original Siding on South Elevation

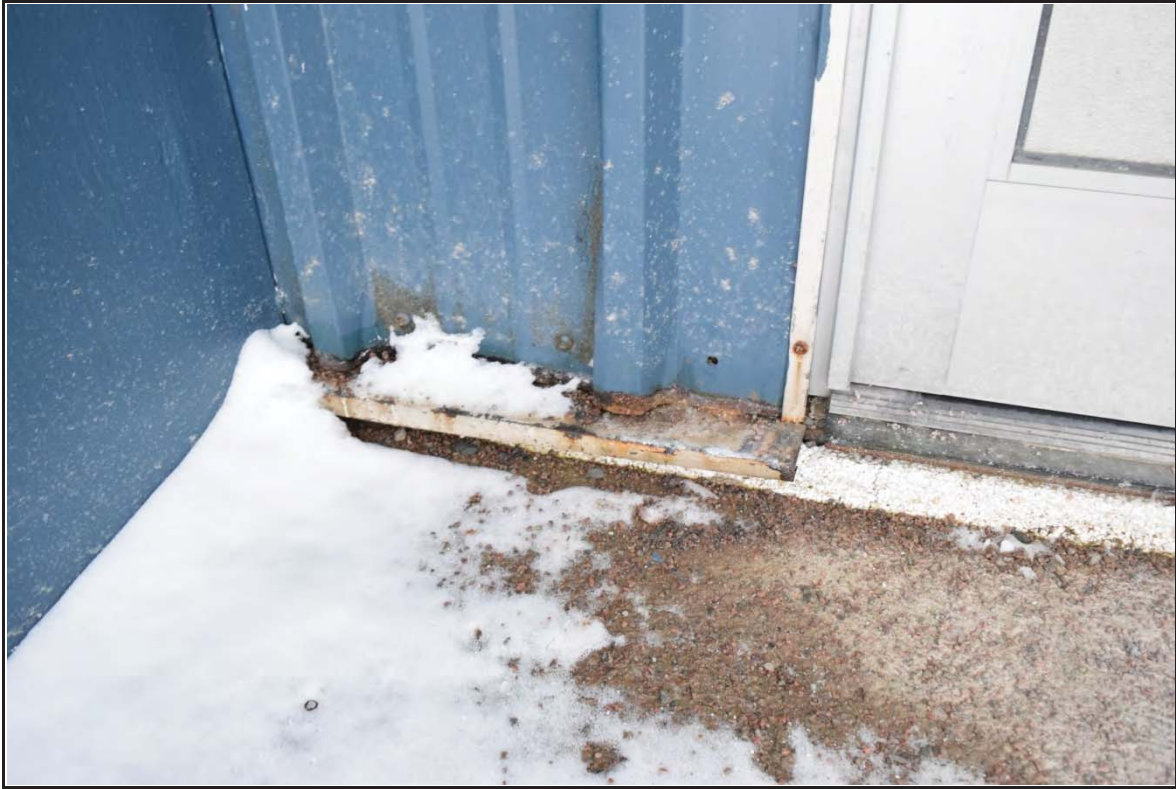
Photo 9: Corrosion at Base of Siding on North Elevation

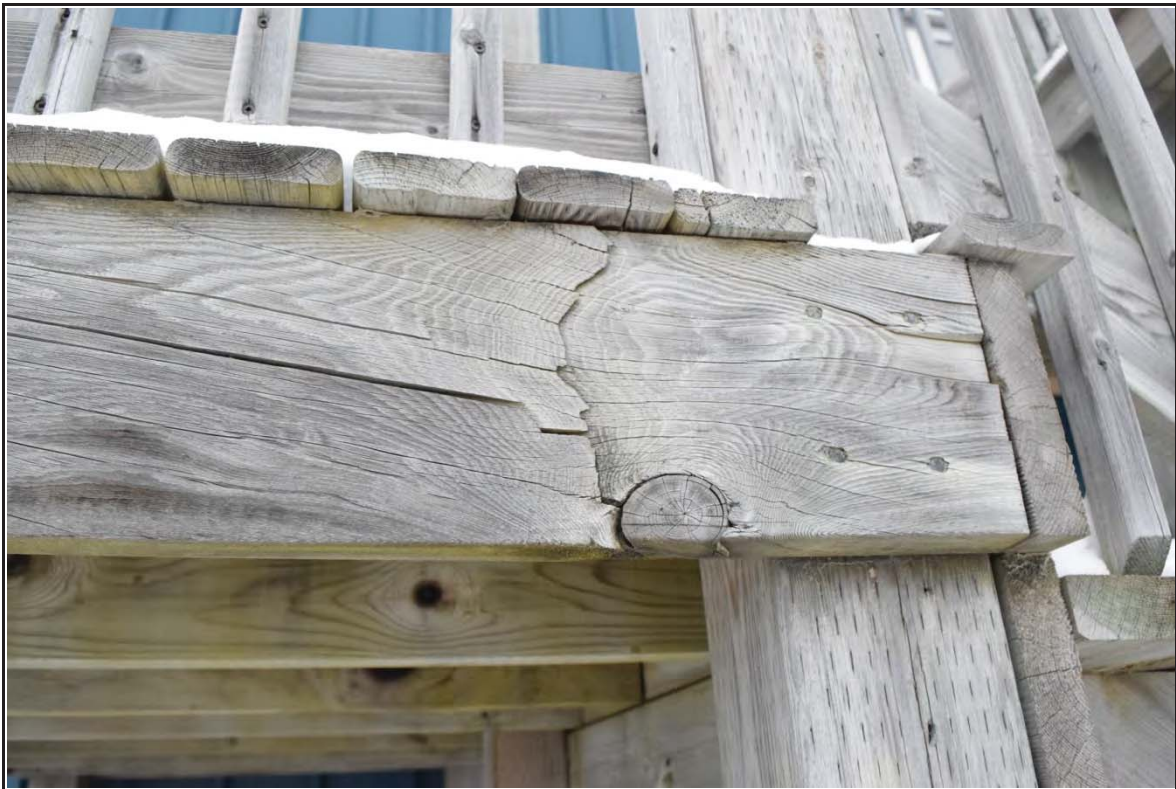
Photo 10: Cracking to Wood Stair Rim Joist

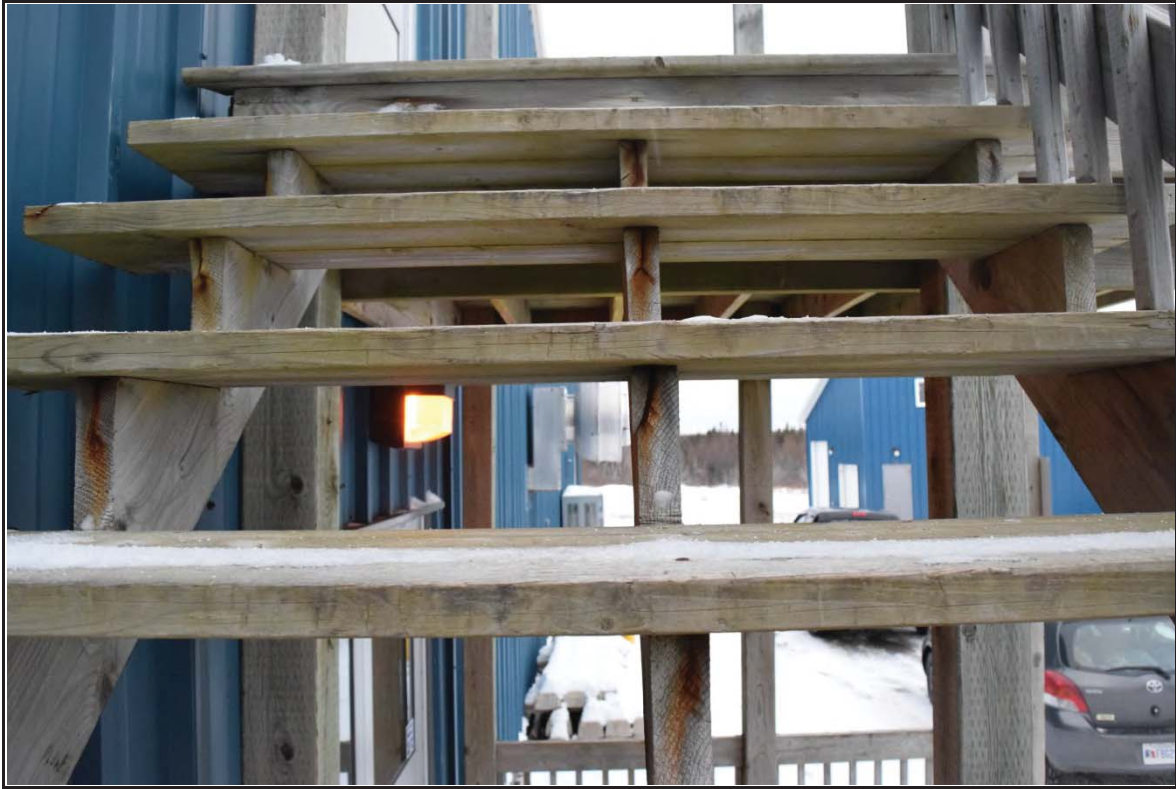
Photo 11: Deterioration to Wood Stair Stringers

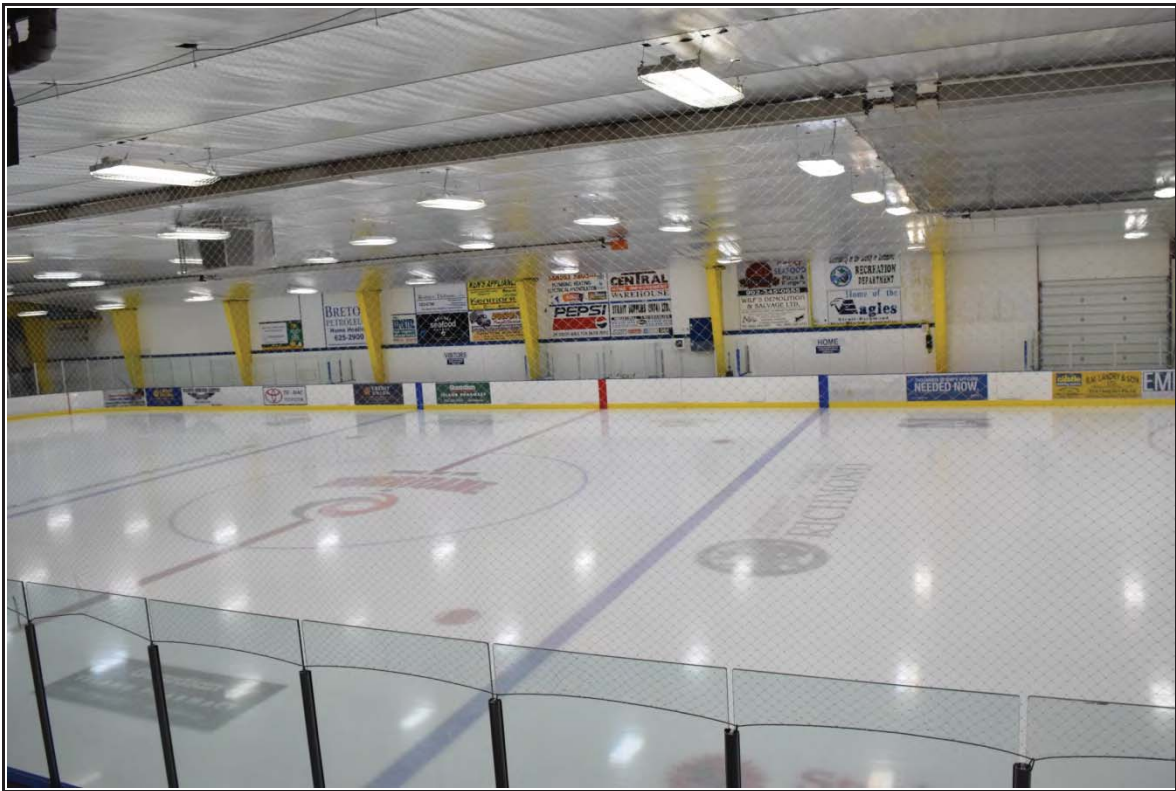
Photo 12: Arena Area, Dasher Boards, Lighting, Protective Nets, and Low-E Ceiling

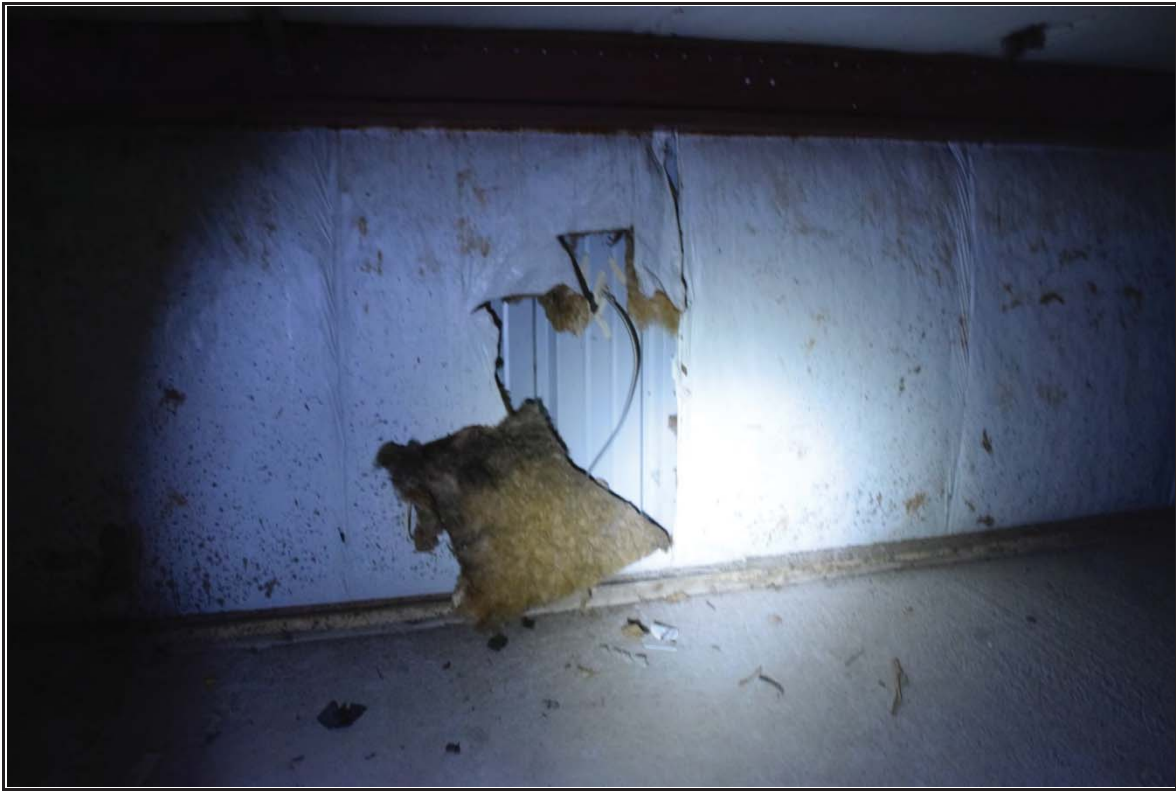
Photo 23: Damage Insulation at Upper Wall

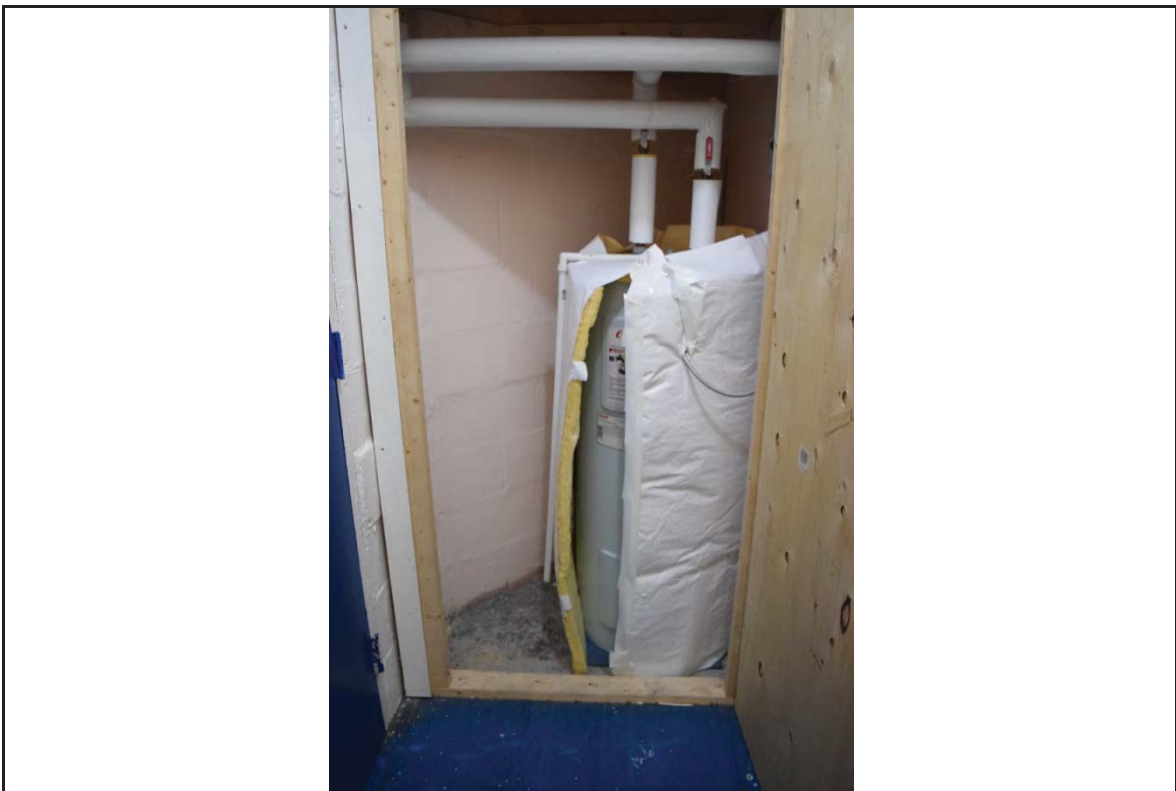
Photo 24: Typical Electric Domestic Water Heater

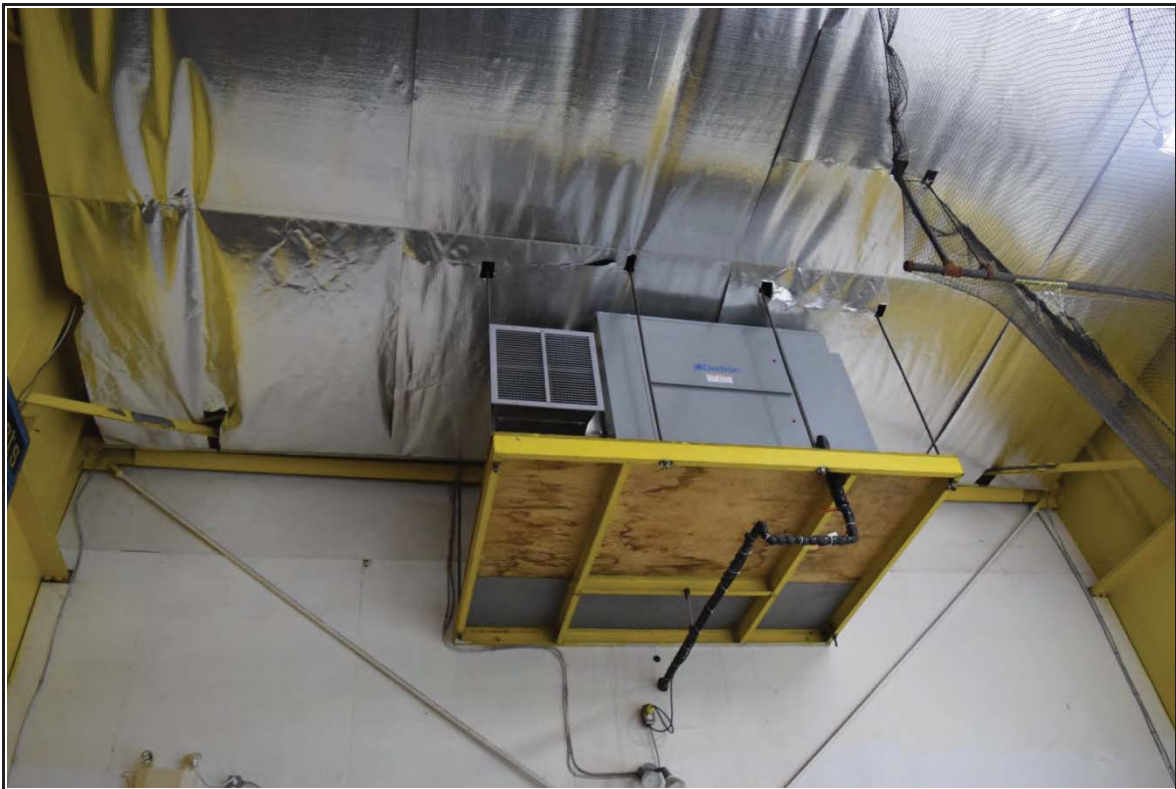
Photo 30: Eastern Dectron Dehumidifier

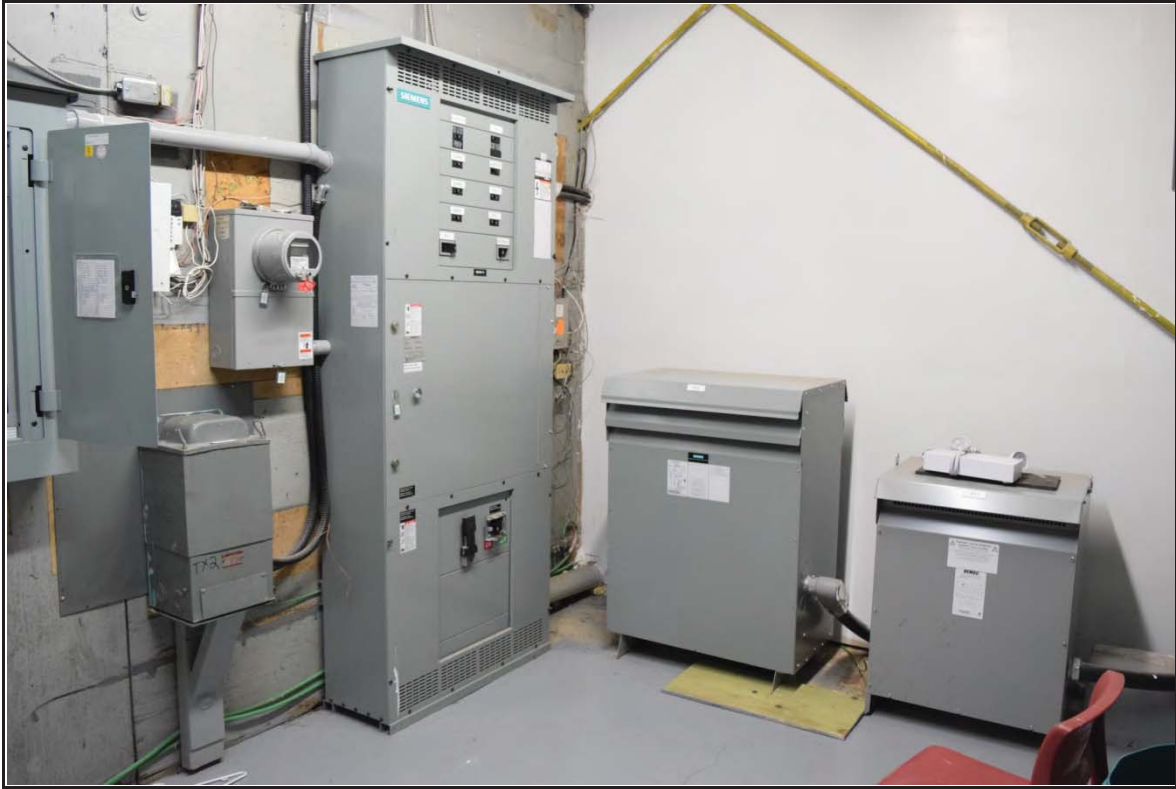
Photo 31: Main 800A 347/600 Disconnect, Distribution, and Transformers

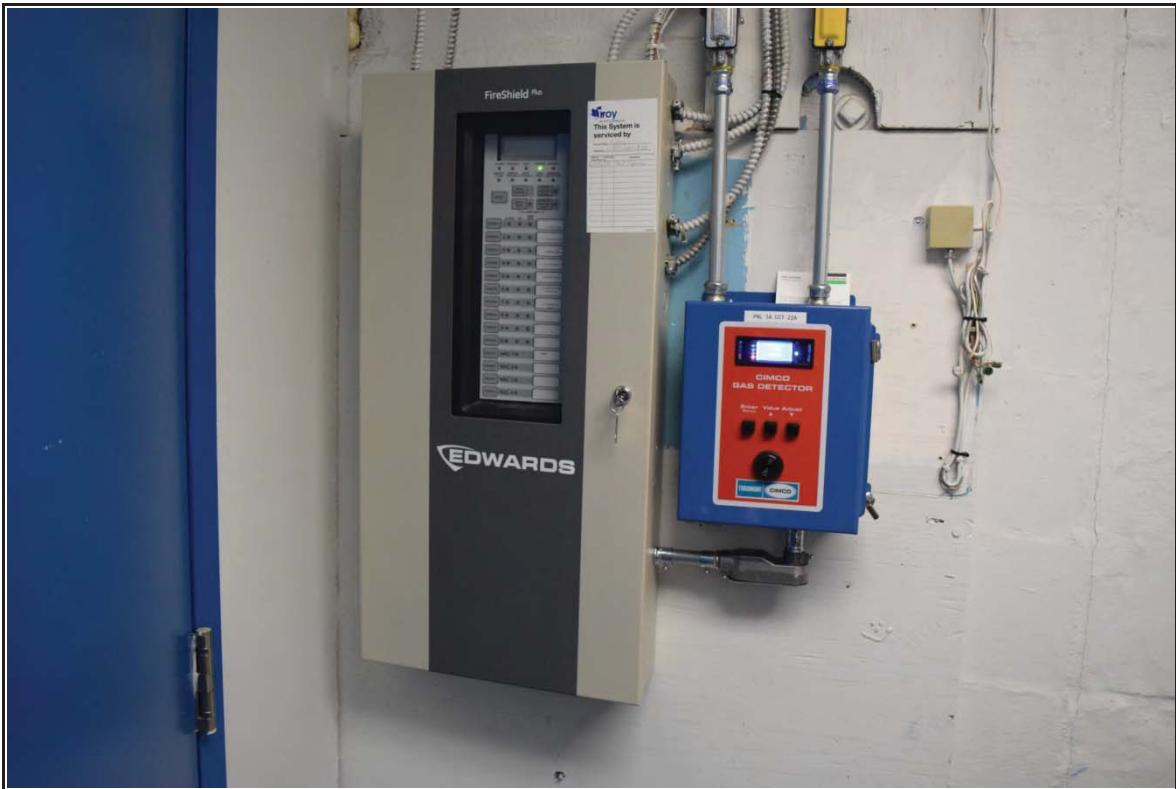
Photo 32: Edwards FireShield Plus Fire Alarm Panel, and Cimco Refrigerant Leak Alarm

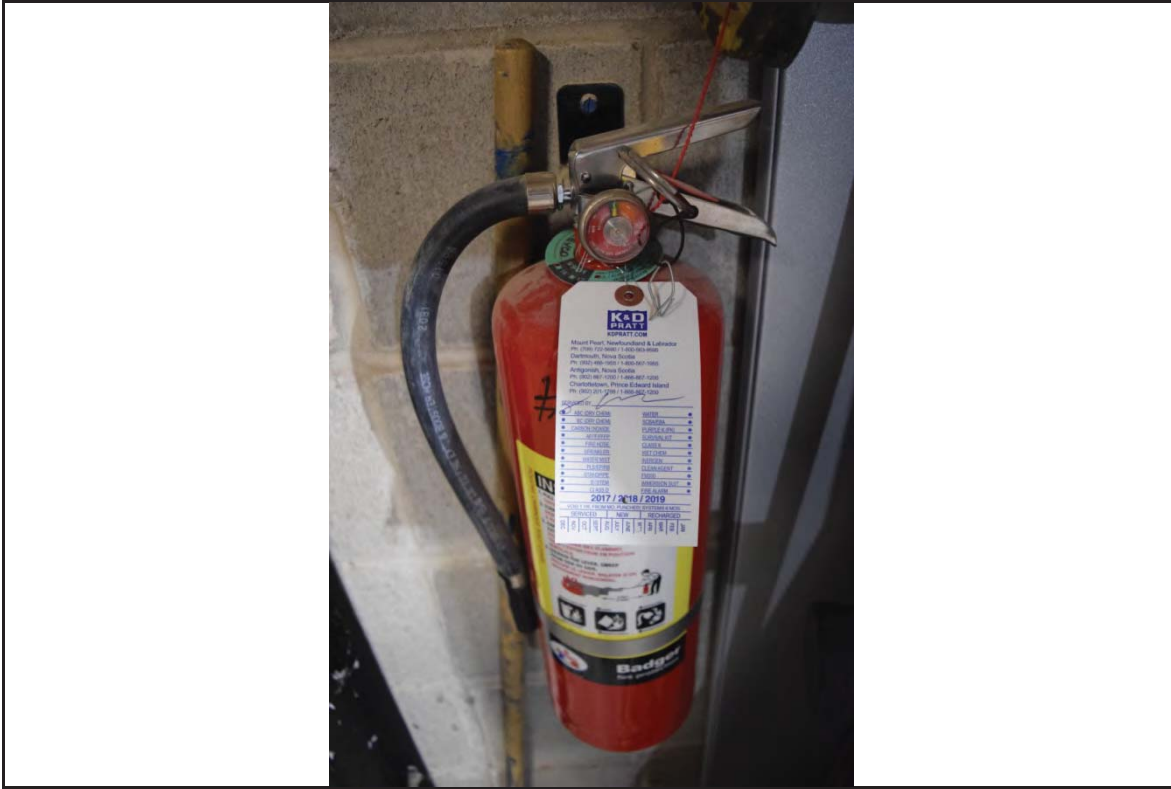
Photo 33: Typical Fire Extinguisher
